SURVEY REPORT: NAU-SR-MPI-001 Rev 02 (Abridged)

MPI RESOLUTION GENERAL CLOSE VISUAL INSPECTION/SURVEY UTILISING DRONE (UAS)

JULY 2017

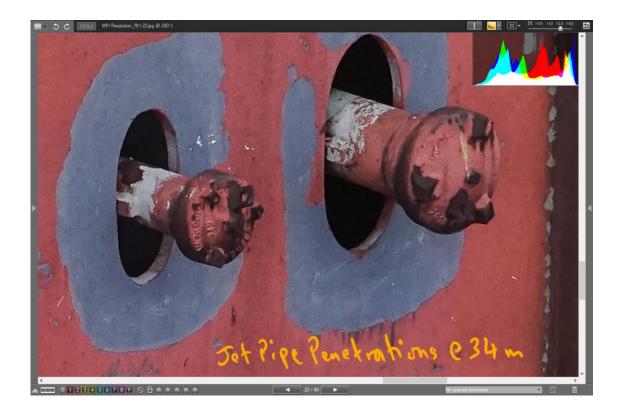
Starboard Aft Leg: Jet Pipe Penetrations; Elevation Marking 34m: Flight 1; Image 22

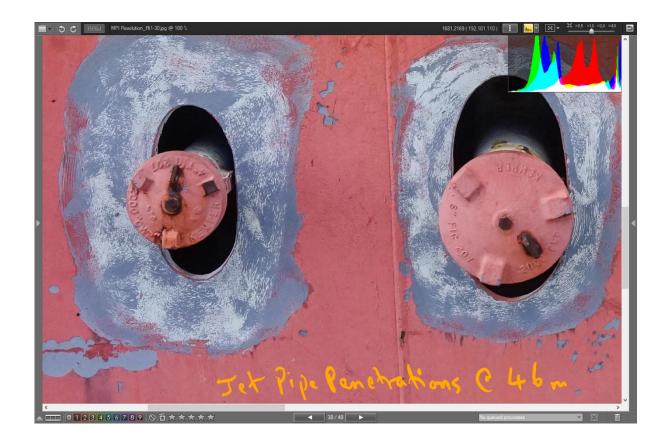
Starboard Aft Leg: Jet Pipe Penetrations; Elevation Marking 46m: Flight 1; Image 30

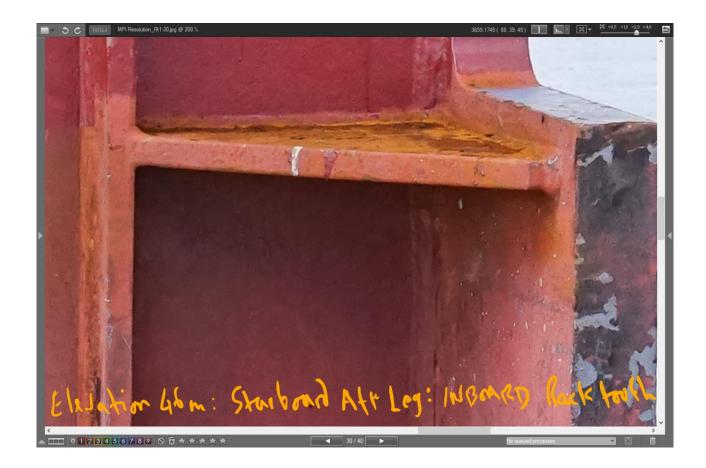
Starboard Aft Leg: Inboard Rack Tooth; Elevation Marking 46m: Flight 1; Image 30

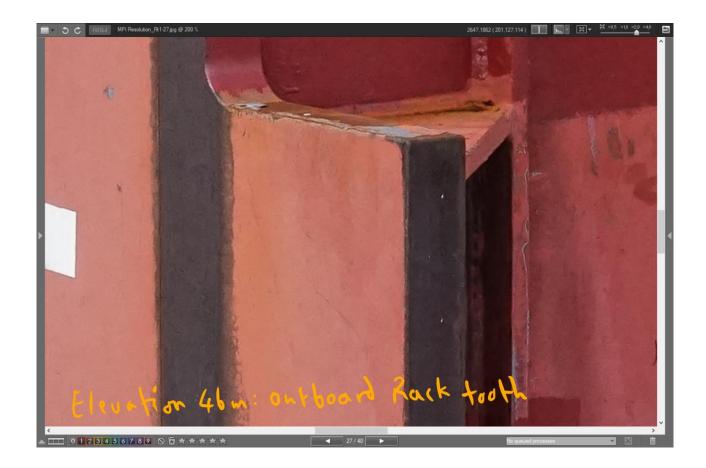
Starboard Aft Leg: Outboard Rack Tooth; Elevation Marking 46m: Flight 1; Image 27

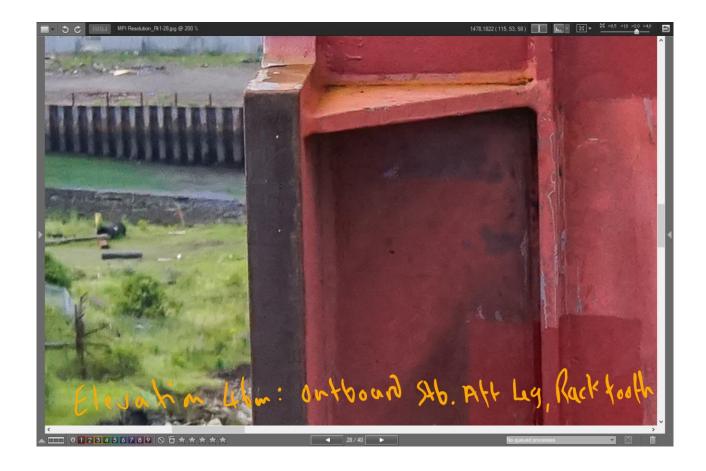
Starboard Aft Leg: Outboard Rack Tooth; Elevation Marking 46m: Flight 1; Image 28

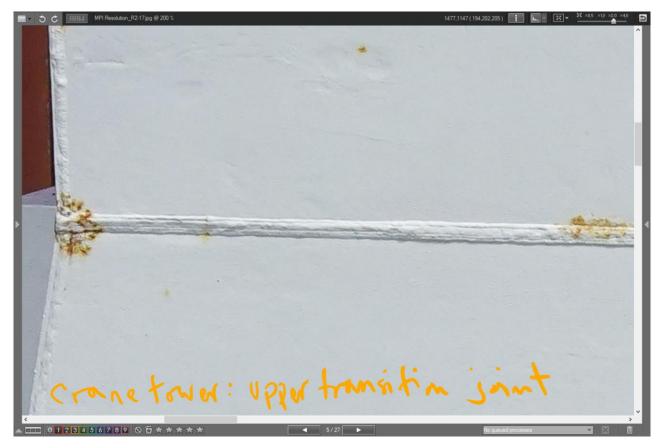
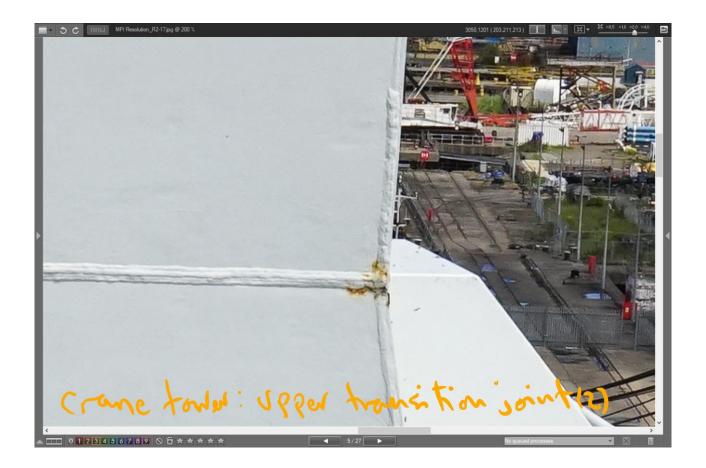
Main Crane Tower: Aft face; Upper Transition Joint: Flight 2; Image 17

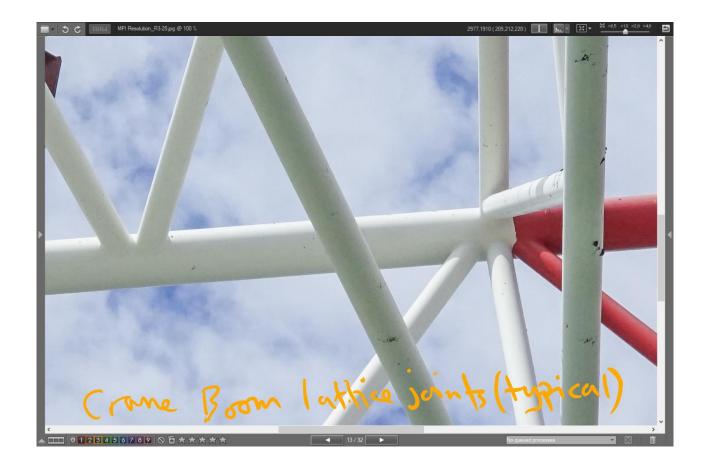
Main Crane Boom Lattice: Flight 3; Image:25

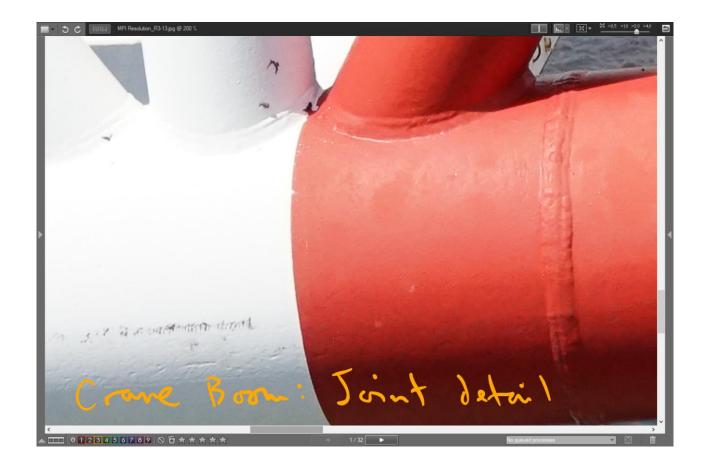
Main Crane Boom; Lattice Joint Detail: Flight 3; Image:13

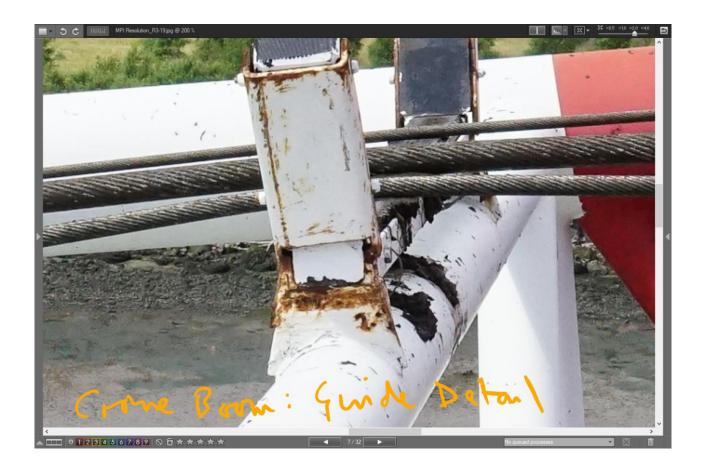
Main Crane Boom; Cable Guide: Flight 3; Image: 19

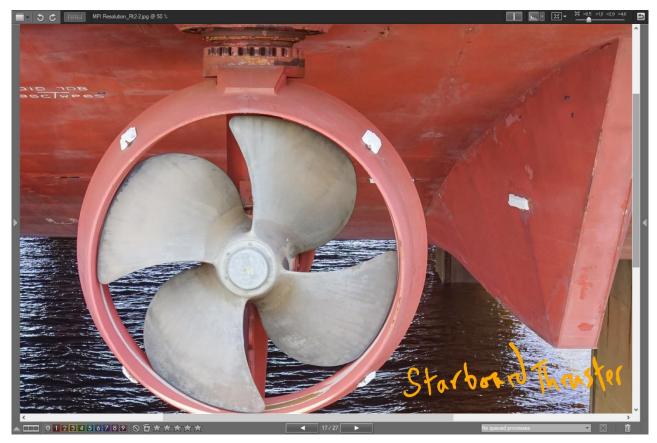
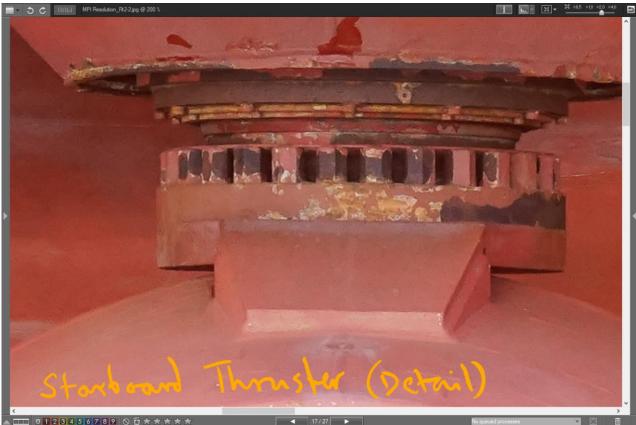
Starboard Aft Thruster; Flight 2 Image 2
