SURVEY REPORT: NAU-SR-XX-YY-0001

LEG STRUCTURE CLOSE VISUAL INSPECTION/SURVEY UTILISING DRONE (UAS)

OCTOBER 2017

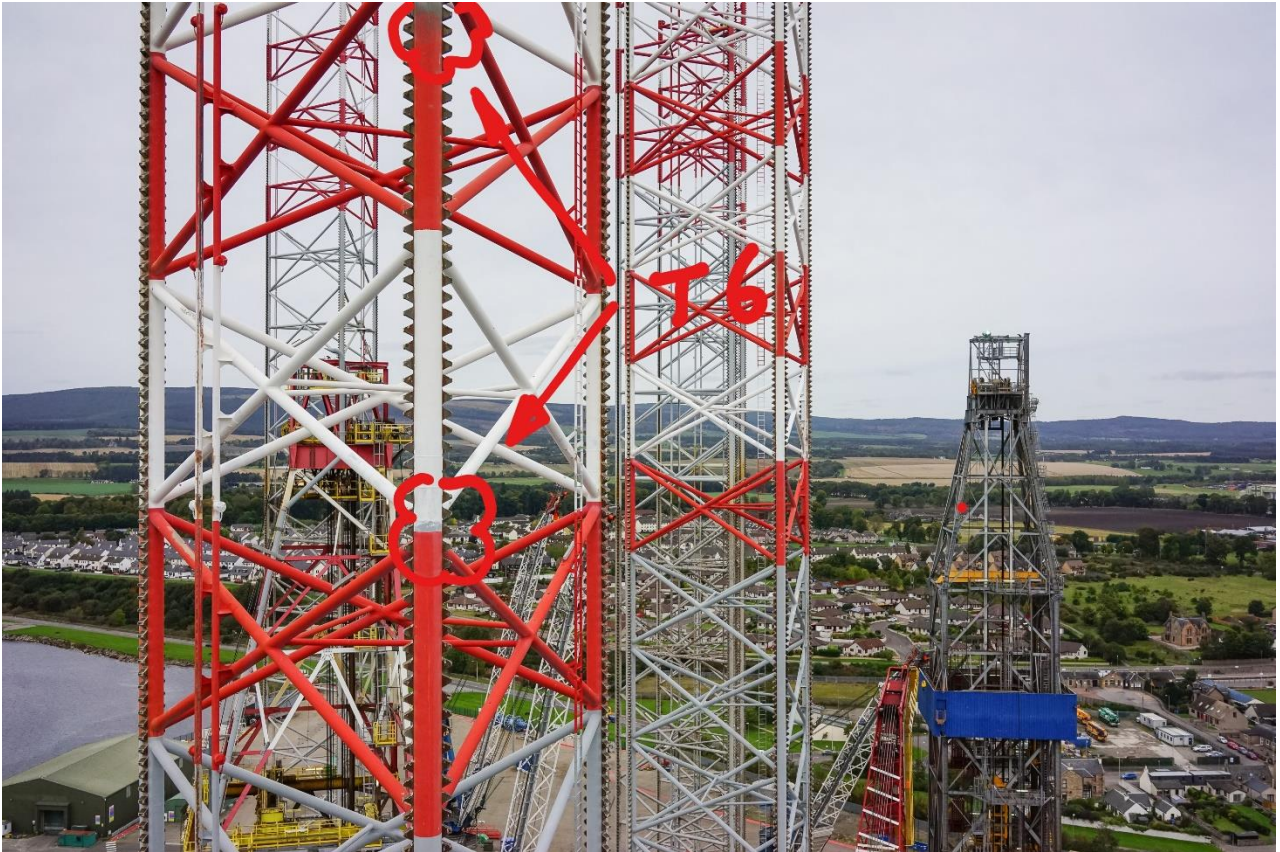
TARGET LOCATIONS: PRE-SURVEY IDENTIFICATION

Leg structure – T1-T3 (lattice nodes, splice joint, rack teeth)

Independent Observer Selected areas – T4 - Further lattice nodes, raw water pipe and fittings, marine growth areas

T5– top of leg

T6 – leg top coating wear areas

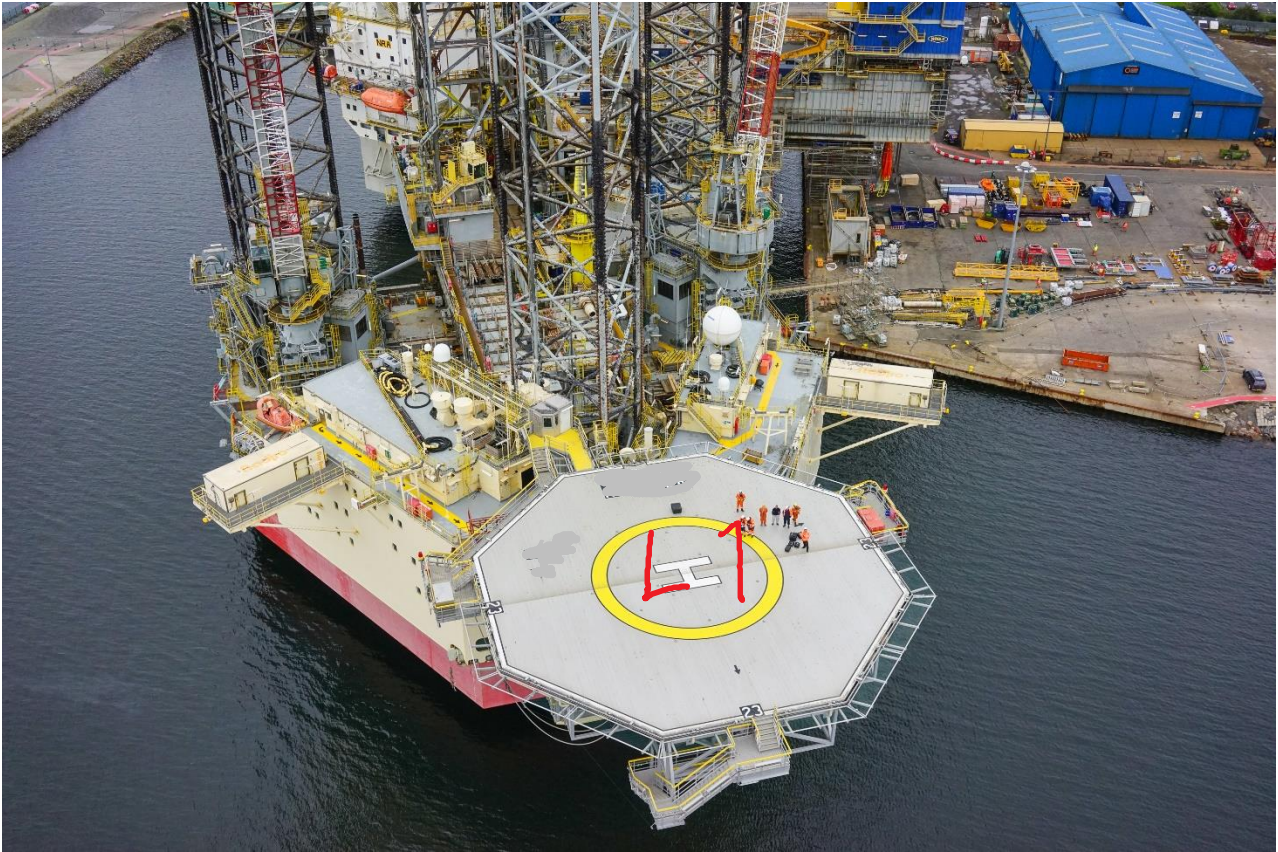
UAS LAUNCH LOCATION, L1, DURING SURVEY

The survey was conducted in accordance with the requirements set out in the approved, revised, Survey Plan, document reference: NAU-SP-MD-001 Rev02, updated and re-issued prior to the survey. Revision was necessary to reflect the change in the launch site from the original, quayside, location to the helideck.
