SURVEY REPORT: NAU-SR-SD-001 Rev 01_abridged
HULL STRUCTURAL VISUAL INSPECTION UTILISING DRONE
(UAS)
MARCH 2017

A pilot survey by UAS (Unmanned Aerial System, or “drone”) of the hull structure of a semi-submersible drilling unit was performed on 27th February, 2017 whilst the rig was moored inshore at Invergordon, awaiting mobilisation.

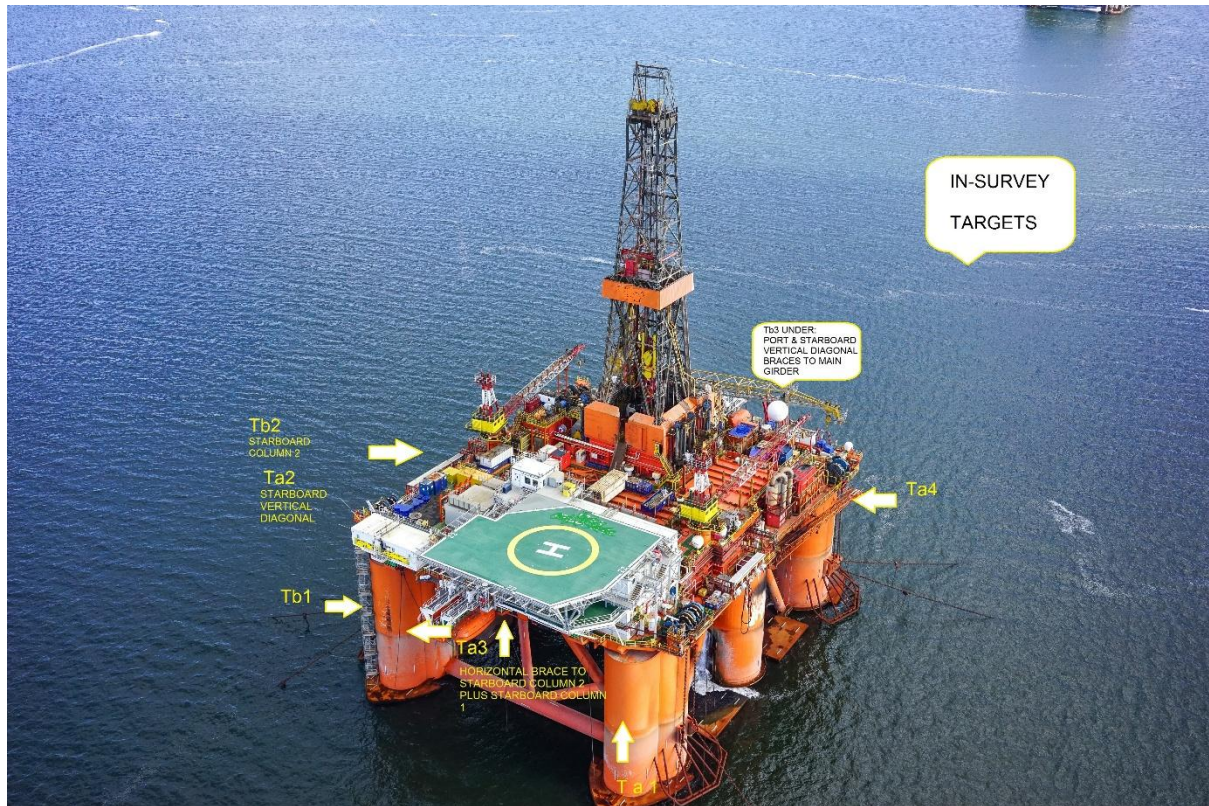
TARGET LOCATIONS: IN-SURVEY IDENTIFICATION

During the survey, additional area were identified by the rig owner representative and the UAS Surveyor on board the workboat. These were examined in detail and are identified on the Target image as T (a1) etc.

Ta1:PC1 Ta2:SVD12 Ta3:H2, SC2

Ta4:PC3 Tb1:SC1 Tb2:SC2 Tb3:PVD1, SVD1

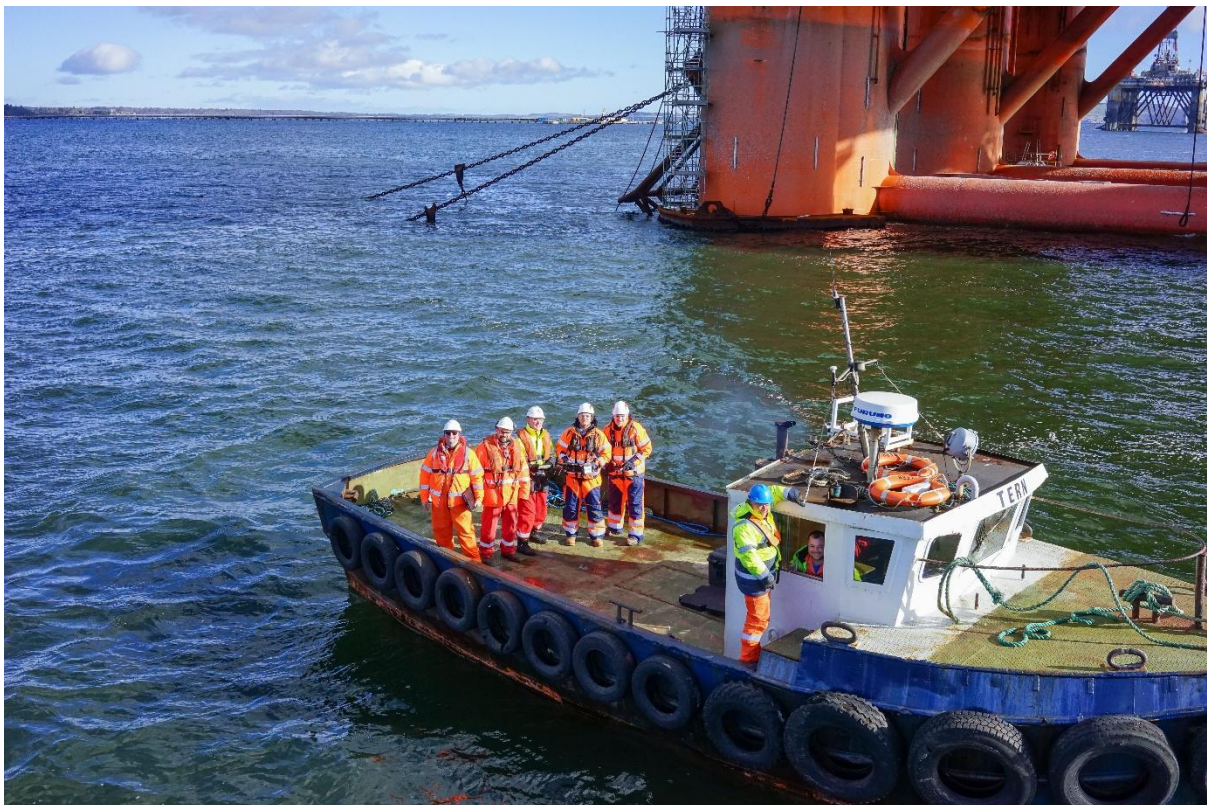
SURVEY VESSEL – PICTURED FROM THE UAS

The survey was completed without disruption to the rigs' operations from the workboat pictured below. The drone (UAS) was hand-launched and retrieved from the deck of the vessel. No intervention from the rig was required.

The vessel utilised represents the minimum size required to safely perform the survey, assuming a UAS team of 3 plus one client representative on-board in addition to the crew of two.
